# CLATSOP ROUNDHOUSE

Newsletter of the Astoria Railroad Preservation Association, Incorporated

Summer 2010

## Boiler Inspected by FRA

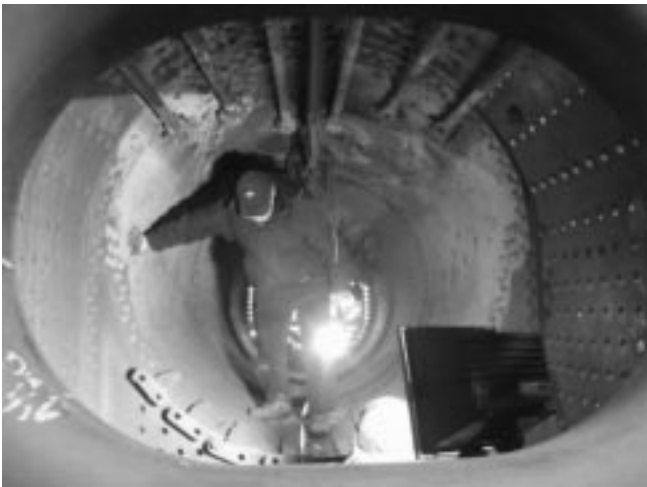
Last December, we were privileged to a courtesy inspection of our boiler repairs by Gary Groff. Steam Locomotive Inspector for Federal Railroad Administration Region 8, Before we installed the new firebox, we felt it was imperative to give the governing authority an opportunity to inspect our work. Some parts of the “pressure space”, specifically the area between the firebox and the boiler are simply not accessible with the firebox and stay bolts in place. Having the firebox out, gave Gary an unique opportunity to check these otherwise inaccessible spots. Please note that once the firebox is installed, the only access to the interior of the boiler is through the steam dome at the top of the boiler, a small opening only 20 inches in diameter.

Inspecting the boiler

We spent several hours together as Gary scrutinized the boiler and our repairs. He came to the conclusion that our repairs and documentation more than meet the required standards and we were given a green light to install the new firebox. A special thanks to Gary for coming down to Astoria to visit our project.

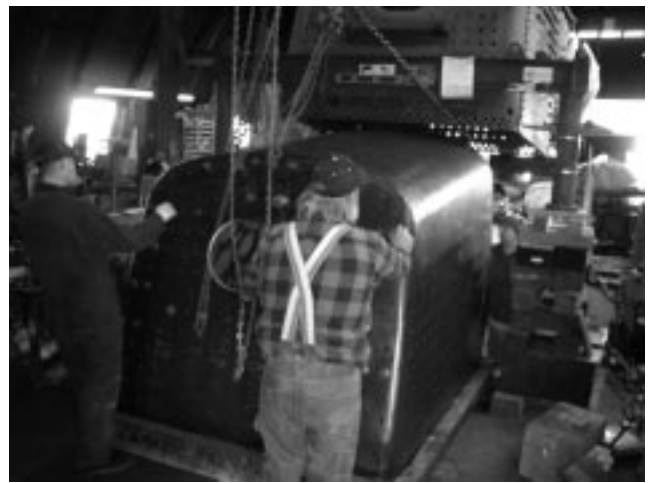
After the FRA inspection of the boiler last December, we installed the new fabricated firebox. This process involved lifting the entire boiler about 4 more feet in the air, then rolling the firebox under the boiler (utilizing sections of 4 inch pipe as rollers). The boiler was then lowered back down to a convenient height for riveting the mud ring.

The firebox goes in

We first attached the mud ring to the firebox via several “line up” pins. The firebox/mudring combination was then raised to its proper position in the boiler and bolted in position through the rivet holes. This was quite a snug fit and required the fabrication of some rather innovative tools to get all three pieces to line up perfectly.

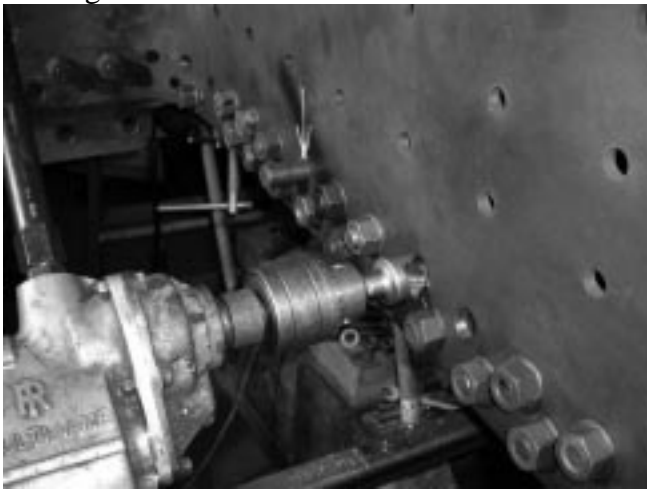
The next step is to rivet the firebox to the boiler through the mudring. Since #21 burns oil and not coal, the heads of the rivets on the inside of the firebox are a countersunk oval head form. This is because the inside of the firebox is lined with fire brick up about 2 feet and a standard button head would prevent the brick from laying against the sheet. To countersink the holes for the rivet heads, we built a special piloted tool that cuts down on "chatter" during the cutting and uses a replaceable carbide insert as the cutting edge. Thanks to Bruce Hall for the CNC milling of this tool and to Stack Metallurgical for heat treating it.

Countersink tool at work

We have countersunk all of the 240 large rivet holes and have also measured the volume of each hole to ascertain the length of a 7/8" rivet required to completely fill the hole. The holes are 1/16" larger in diameter than the rivet to facilitate insertion of the red hot rivet and extra length of material must be included to completely fill the hole when it is squished.

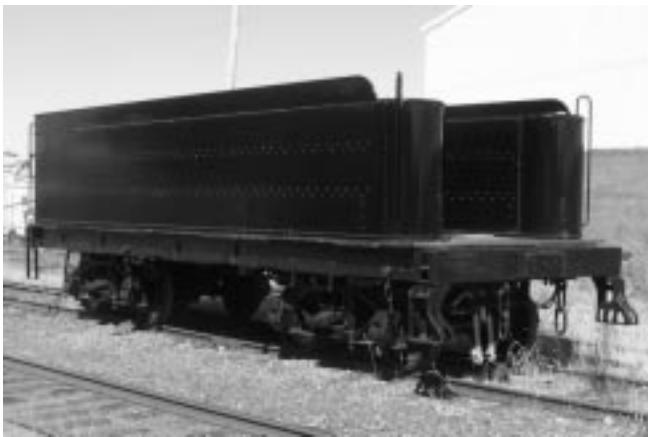
Most of the recent work during the past 3 years has been on the tender. The tender or “coal car” is the car immediately behind the locomotive that carries the water and fuel needed to make the steam that powers the locomotive. In the case of #21 the fuel is oil rather than coal and there are separate water and fuel tanks.

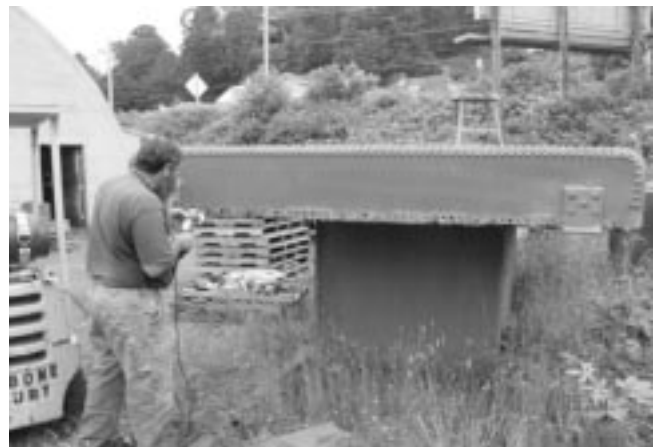
The fuel tank had much less corrosion than the water tank since it was partially full of oil, so we have been able to restore it. First it needed to be cleaned inside and out. Keith Grimes did quite a bit of the inside cleaning. The engine burned a fuel oil called Bunker C which is pretty similar to road tar. There was several inches of this fuel left in the tank. In addition, sand and silt had gotten into the tank over the years so it was a sludgy mess. We also had to replace about 50 rivets in the back of the tank where debris had accumulated and badly corroded them on the outside.

Casey removing corroded rivets

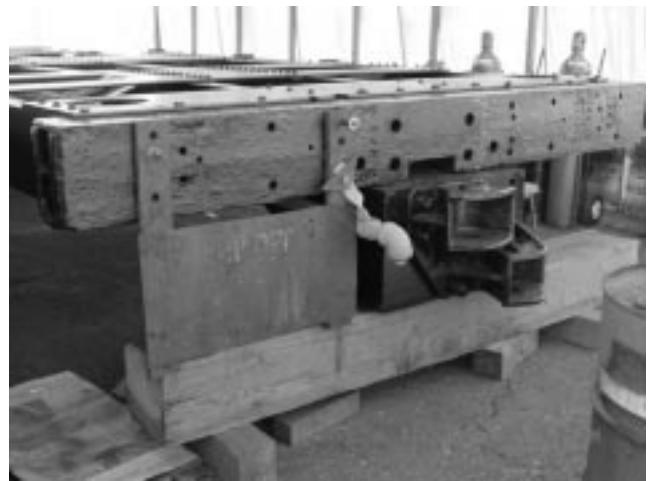
The frame had been bent as a result of a hard coupling in the past. So we fixed the bends. The frame was sandblasted and painted. As originally constructed the frame had large wood bumpers front and rear. However sometime after the frame was bent, the rear bumper was replaced with a steel beam. After the frame was fixed the bumper was crooked. A Job Core Student from Tongue Point welded up the old bumpers bolt holes, then new holes were drilled.

An item of special interest is that our coupler casting has two pockets, one for standard gauge the other for narrow gauge. A second coupler mounted in the narrow gauge pocket would be used to switch narrow gauge cars on dual gauge track at the interchange with a narrow gauge railroad.

The Tender Frame

A steam heat pipe runs under the tender to provide heat to passenger cars. Some fittings needed to be replaced, new brackets were manufactured and fitted and new insulation was

applied to the pipe. Portions of the signal and brake pipes were also replaced and the pipes reinstalled with new fittings. The brake cylinder was rebuilt with new seals and the dump valve was also rebuilt.

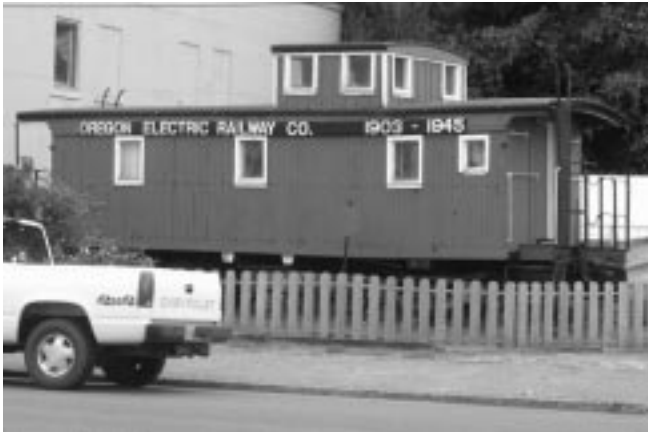
In the summer of 2008 we saw a cooperative effort to spruce up ARPA's Oregon Electric caboose #026. Situated adjacent to West Marine Drive in Astoria, the caboose is on static display. The Uniontown Association enlisted local Boy Scout Travis Gaydos of Troop 211 to spearhead the new paint job. The task was taken on by Travis as a community service project to help achieve his goal of becoming an Eagle Scout. He first presented the idea to the local Boy Scout Council to obtain approval and then worked out the details for manpower, tools and materials.

The work began with ARPA member Keith Grimes preparing the wooden caboose by pressure washing the worst of the old paint flakes away. Some additional wire brushing, sanding and caulking prepared the wood for paint. Travis Gaydos enlisted the services of fellow scouts, family and friends to help put a new coat of paint on the caboose. While the original color scheme was probably yellow, this time around a traditional red with white and black trim was chosen.
